PASSAIC RIVER BASIN,
TROY BROOK, MORRIS COUNTY
NEW JERSEY

LAKE INTERVALE DAM
NJ00769

PHASE 1, INSPECTION REPORT
NATIONAL DAM SAFETY PROGRAM

MAY 1981

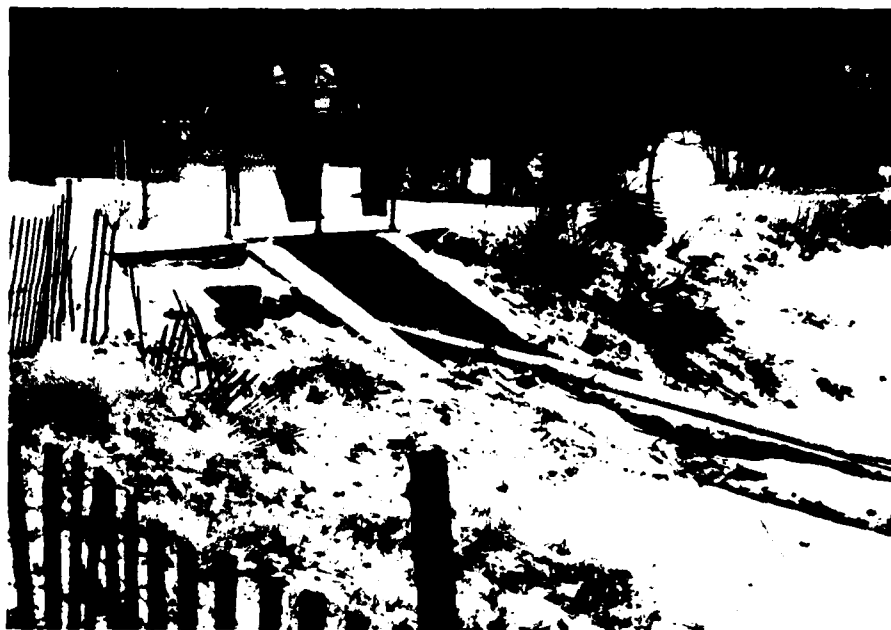
PHOTO 3

UPSTREAM SIDE OF DAM AND SPILLWAY

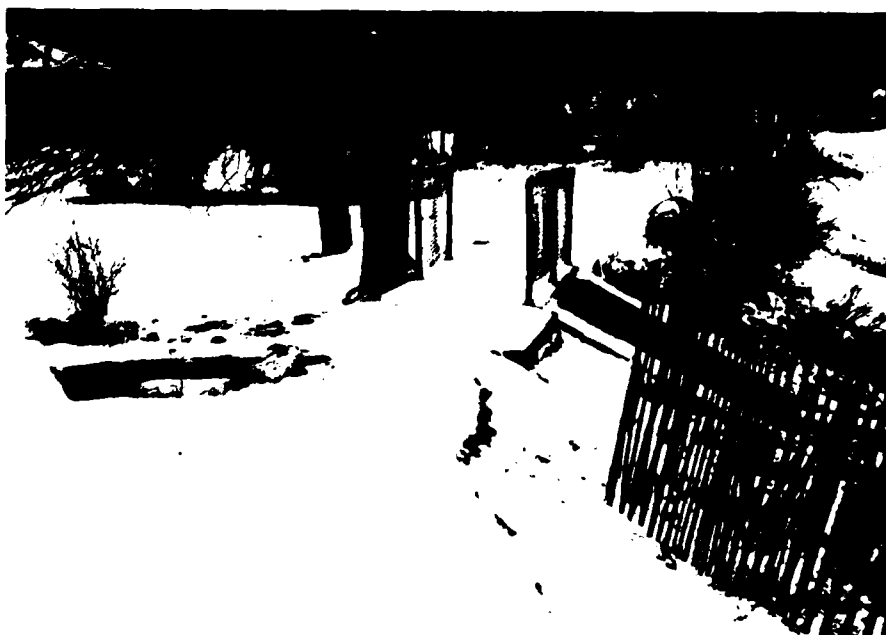
PHOTO 4

CREST OF DAM

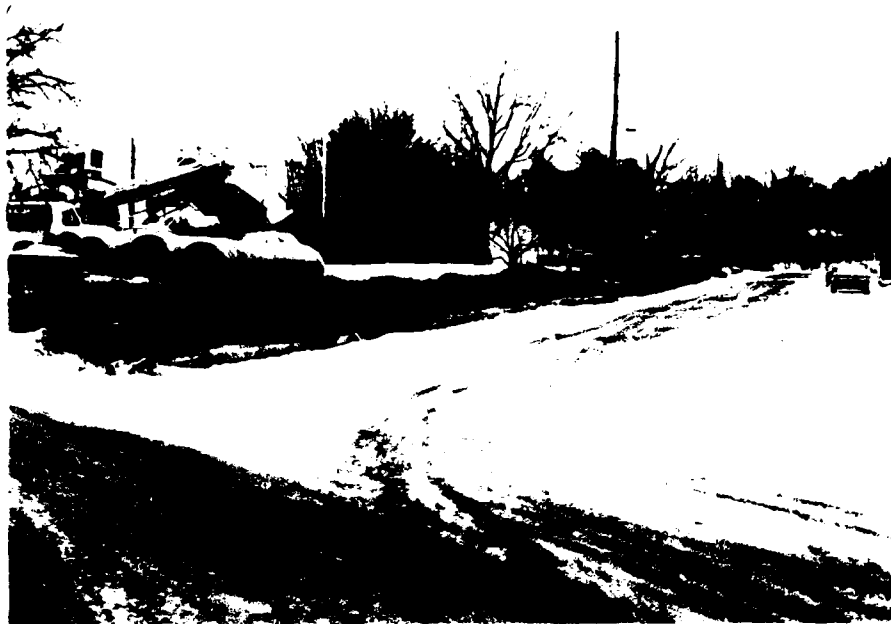
PHOTO 5

| VISUAL EXAMINATION | OBSERVATIONS | REMARKS OR RECOMMENDATIONS |
|--|--|---|
| SLOUGHING OR EROSION OF EMBANKMENT AND ABUTMENT SLOPES | No sloughing observed. Erosion observed on downstream side of embankment adjacent to conc. slope protection. Erosion appeared to be caused by pedestrian activity. | Eroded area should be filled and properly stabilized. |

DOWNSTREAM SIDE OF DAM-LEFT SECTION
